AERONAUTICAL MATERIALS LABORATORY

REPORT NO. NAEC-AML-2436

DATE 11 MAY 1966

DEVELOPMENT OF AN ENVIRONMENTAL WET TEST CHAMBER FOR
SIMULATING CARRIER DECK AND OTHER CORROSIVE ENVIRONMENTS

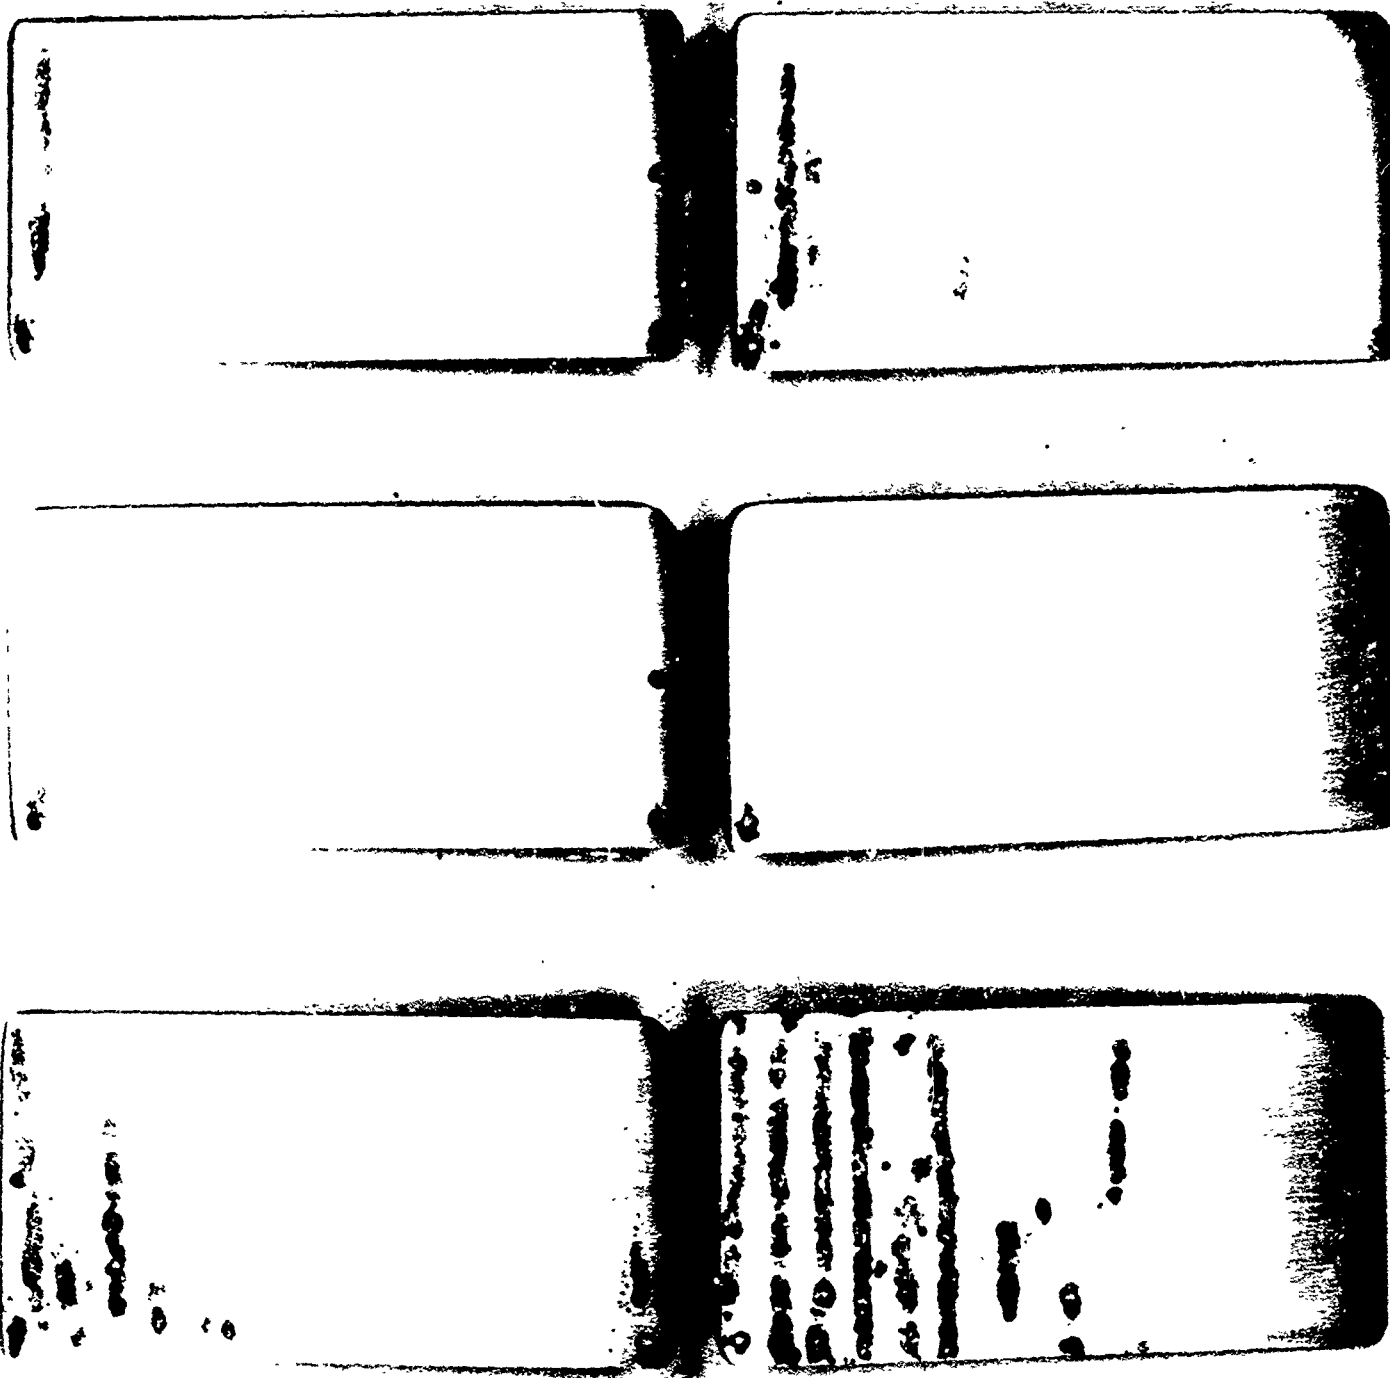
PLATE 22

RESULTS OF EXPOSURE OF STEEL SPECIMENS (COATED WITH A LIGHT OIL CONTAINING
10% INHIBITOR) IN THE JAN-H-792 HUMIDITY CABINET

For this test steel panels were coated with the sample A material. They were exposed in the JAN-H-792 humidity cabinet and during this period daily observations were made. The first failure occurred in 14 days. The 31st day, two more specimens failed followed by another failure on the 32nd day. The test was terminated on the 35th day, with a total result, depicted in Plate 22, of four failures with two passing. Again, as noted in the salt spray tests, where failure occurred it was characterized as random rust streaking, spotting or pitting.

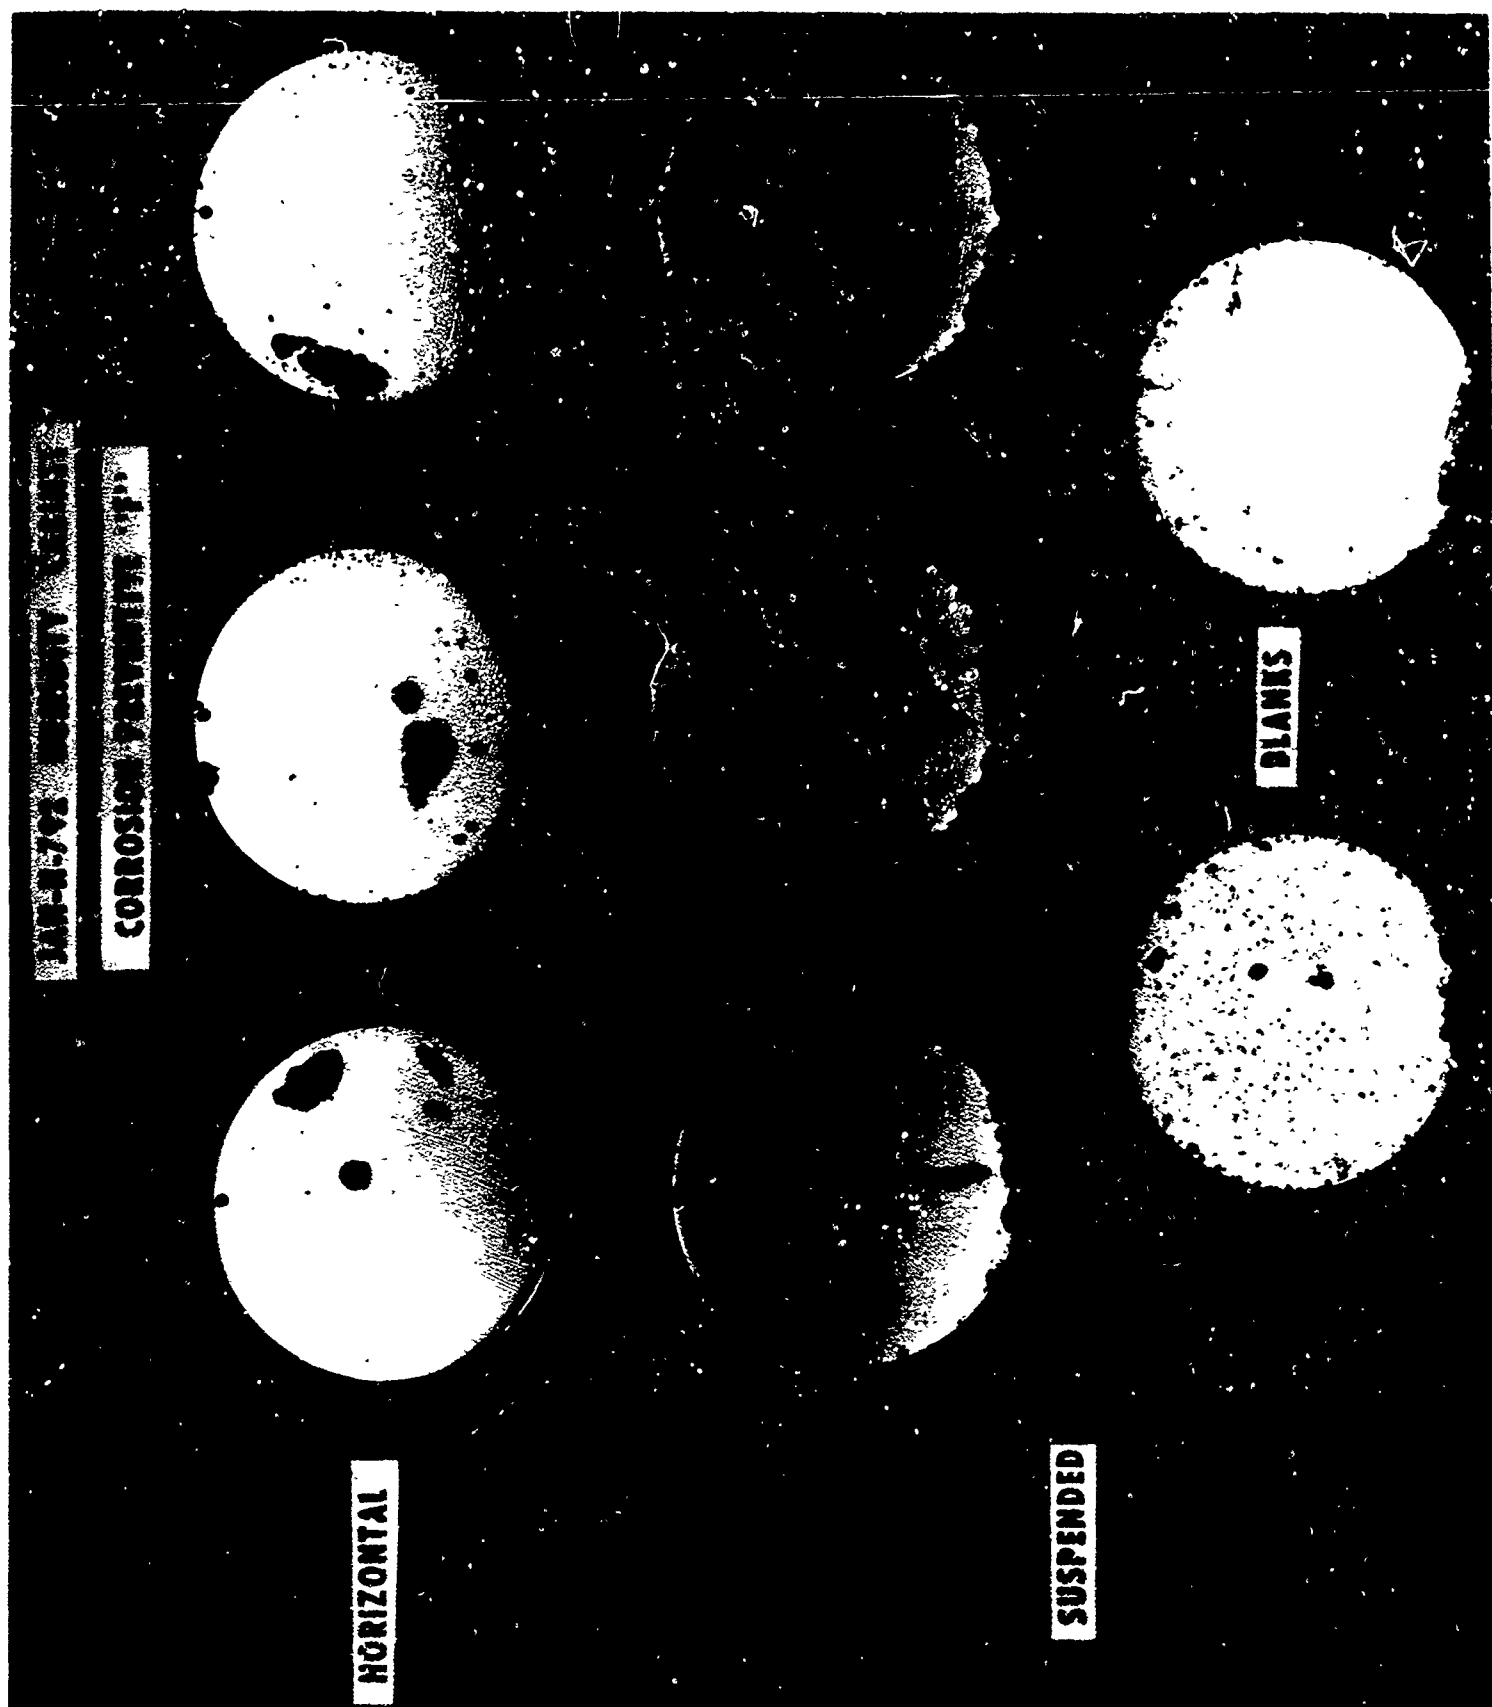
PLATE 23

RESULTS OF EXPOSURE OF STEEL SPECIMENS (COATED WITH A LIGHT OIL CONTAINING 1% INHIBITOR) IN THE JAN-H-792 HUMIDITY CABINET

In still another test, steel discs were coated with a light oil containing 1% exhibitor and exposed in the humidity cabinet. This material, identified as sample F, was used to provide comparative results in a relatively short exposure time. The specimens, shown in Plate 23, displayed non-uniform corrosion patterns.

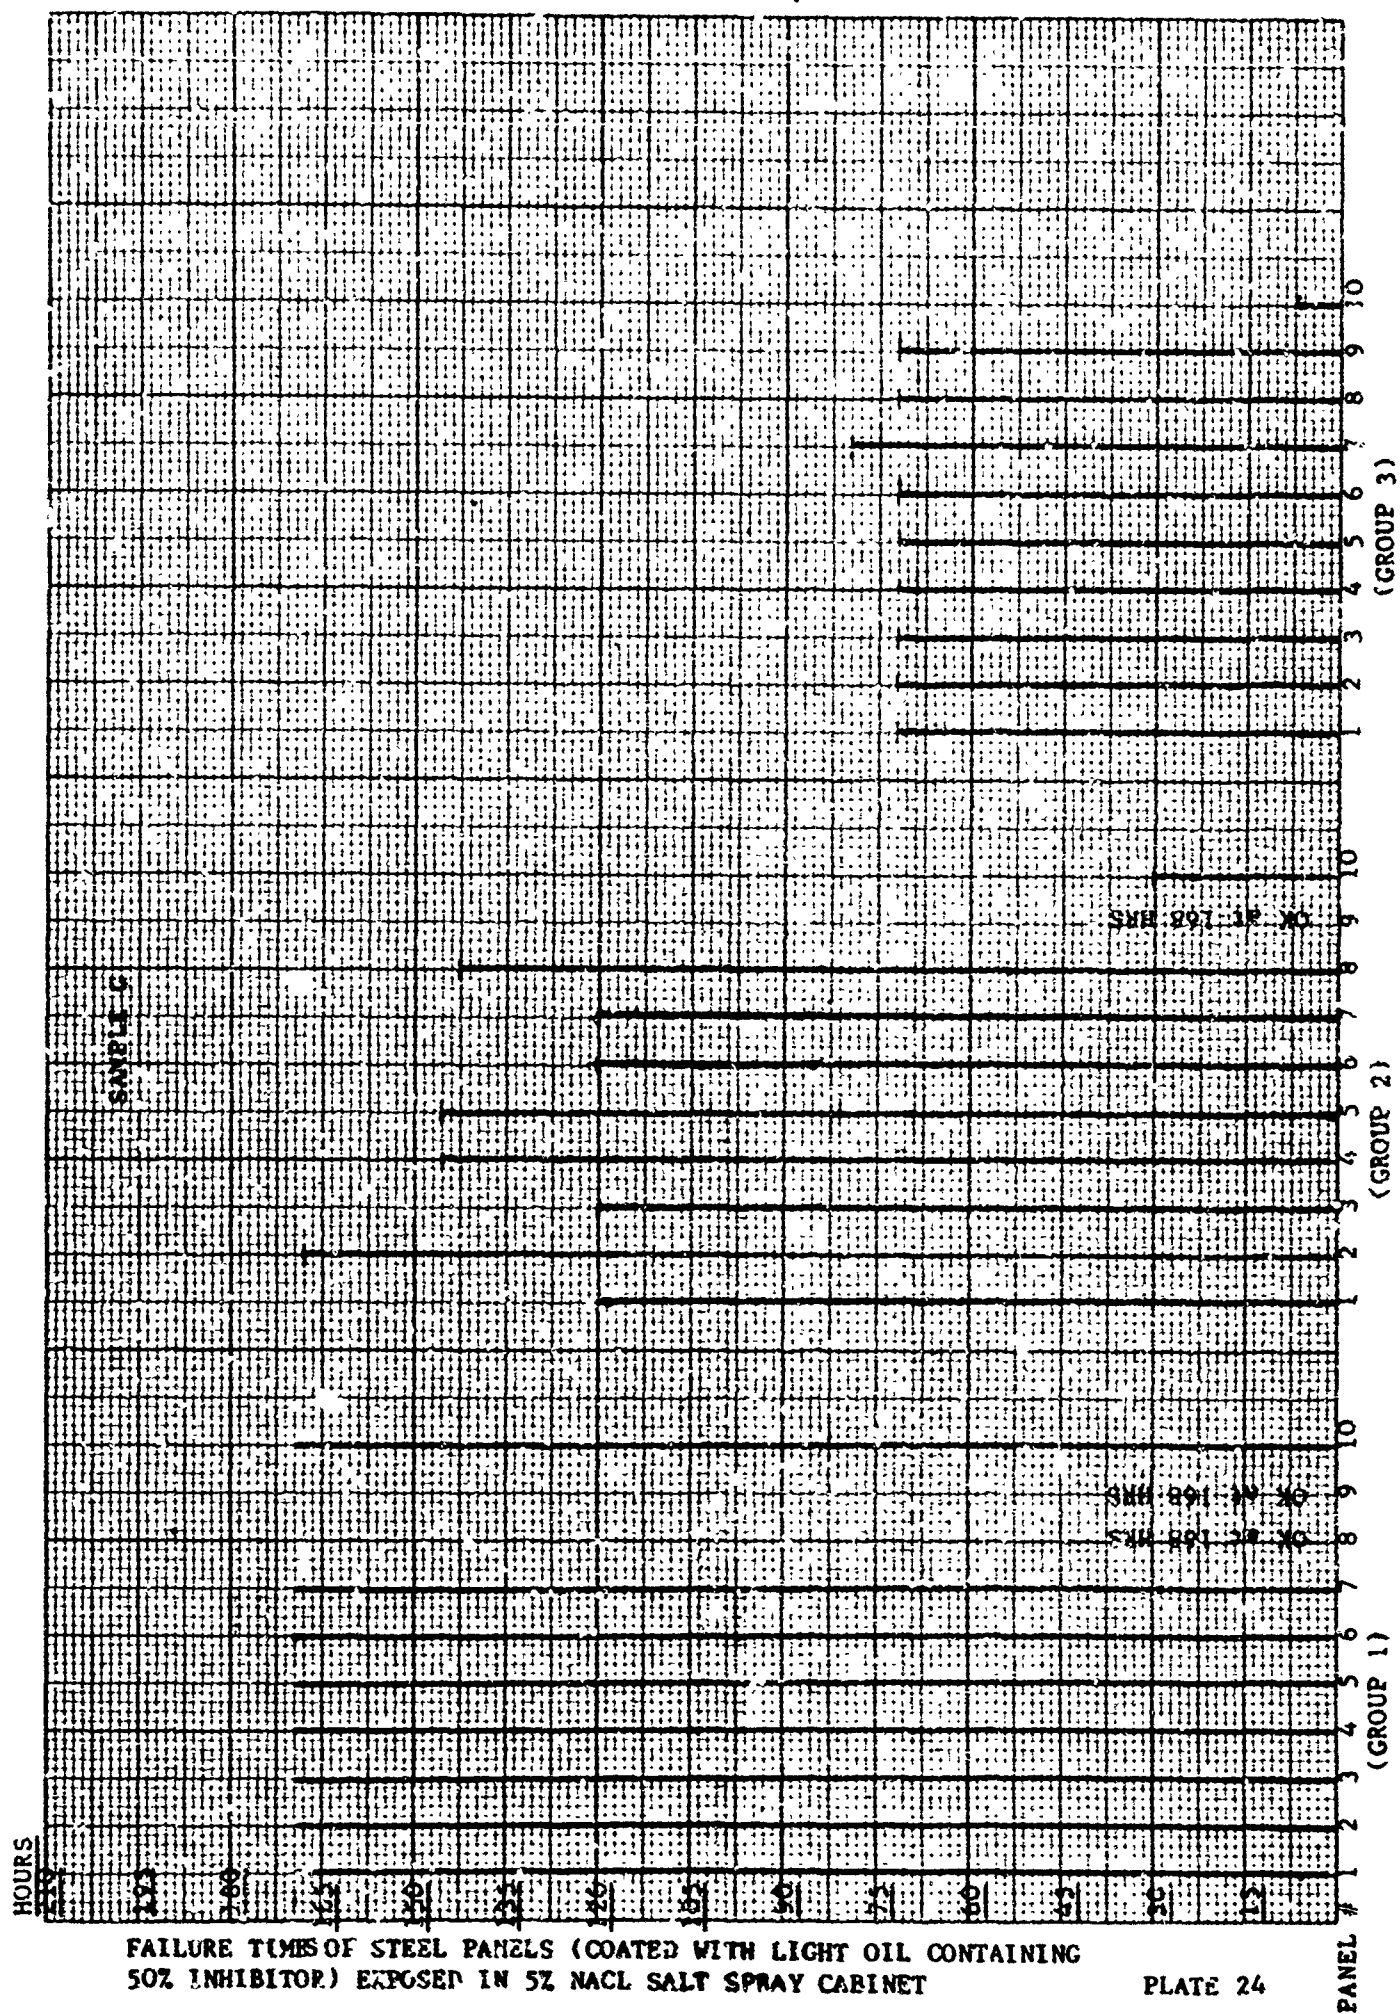
FAILURE TIMES OF STEEL PANELS (COATED WITH LIGHT OIL CONTAINING 50% INHIBITOR) EXPOSED IN 5% NaCl SALT SPRAY CABINET

Two light oils were used here. One, identified as sample G, contained 50% inhibitor, while the other, sample H, contained 75% inhibitor. The sample G material was applied to ten steel test panels and exposed in the salt spray cabinet. Subsequently, another set coated with sample H material was exposed in the same environment. This sequence was repeated over a period of three months until twelve separate sets, six for each oil, had been tested.

During the exposure periods observations were made twice daily. Failure time of a given specimen, was recorded as the time in hours when three or more distinct rust spots were observed. The area within 1/4" of the periphery was not included in the evaluation. A test was terminated when a minimum of seven panels in a set failed. The test sets were started in the cabinet at irregular intervals so that none of the sets, coated with identical materials, ran concurrently. Charts were drawn up whereby the failure time of each panel could be determined as well as the failure time amongst sets. They are represented in Plates 24 to 27 inclusive. A comparison of the results revealed a lack of correlation amongst sets, and the failure times of members of a set usually failed to coincide. Also almost all the specimens displayed corrosion patterns that were not uniform, usually appearing in the form of random corrosion, and/or pitting and rust streaking.

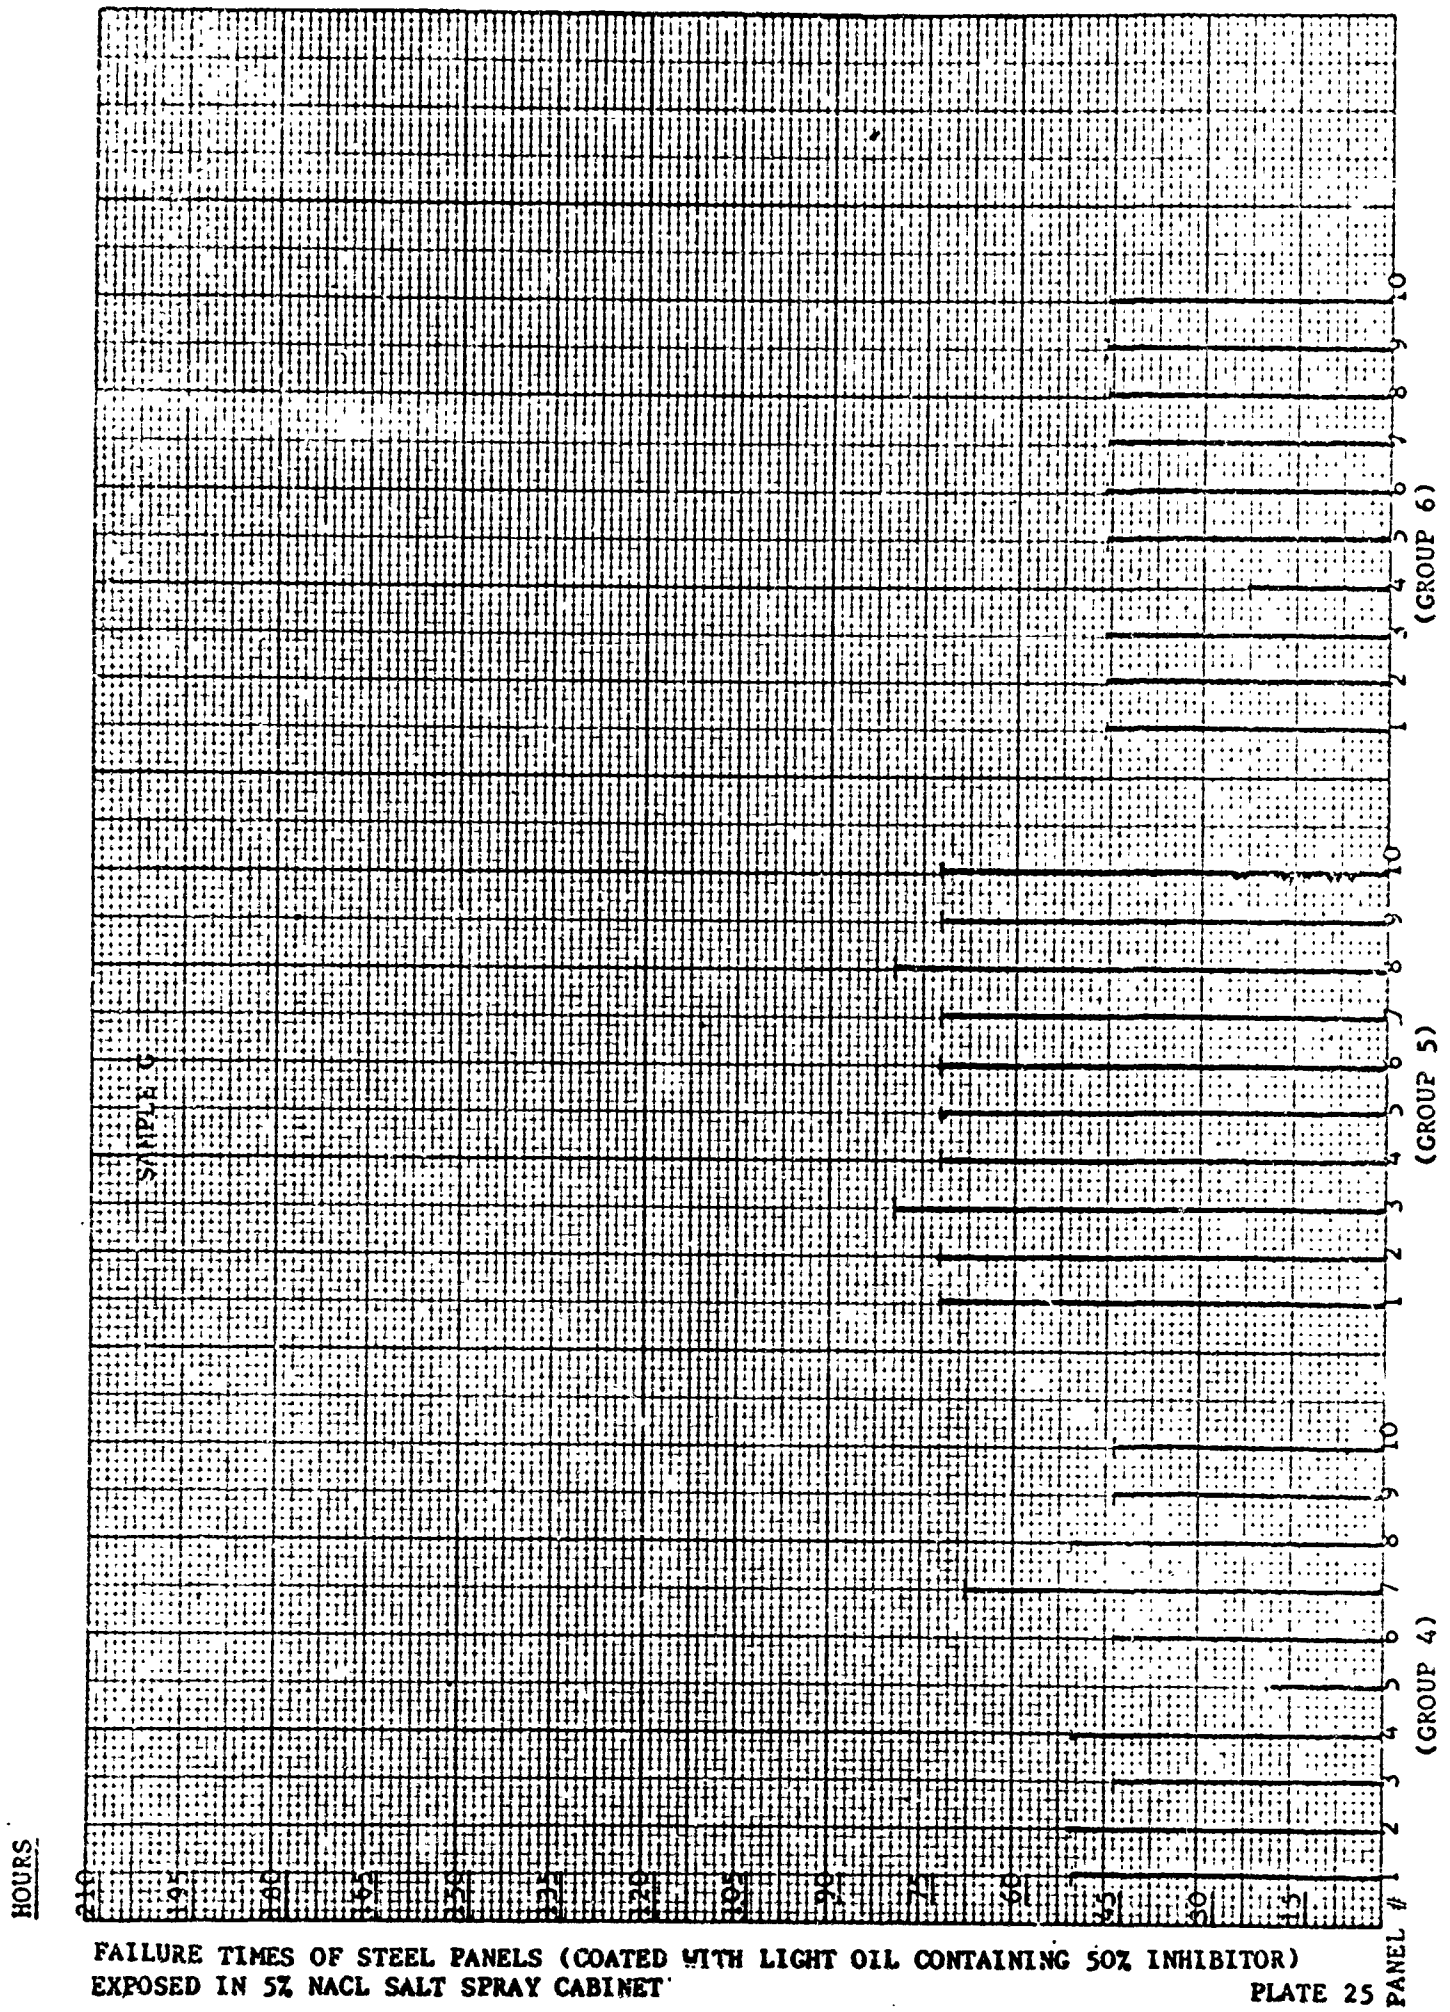
FAILURE TIMES OF STEEL PANELS (COATED WITH LIGHT OIL CONTAINING 50% INHIBITOR)
EXPOSED IN 5% NaCl SALT SPRAY CABINET

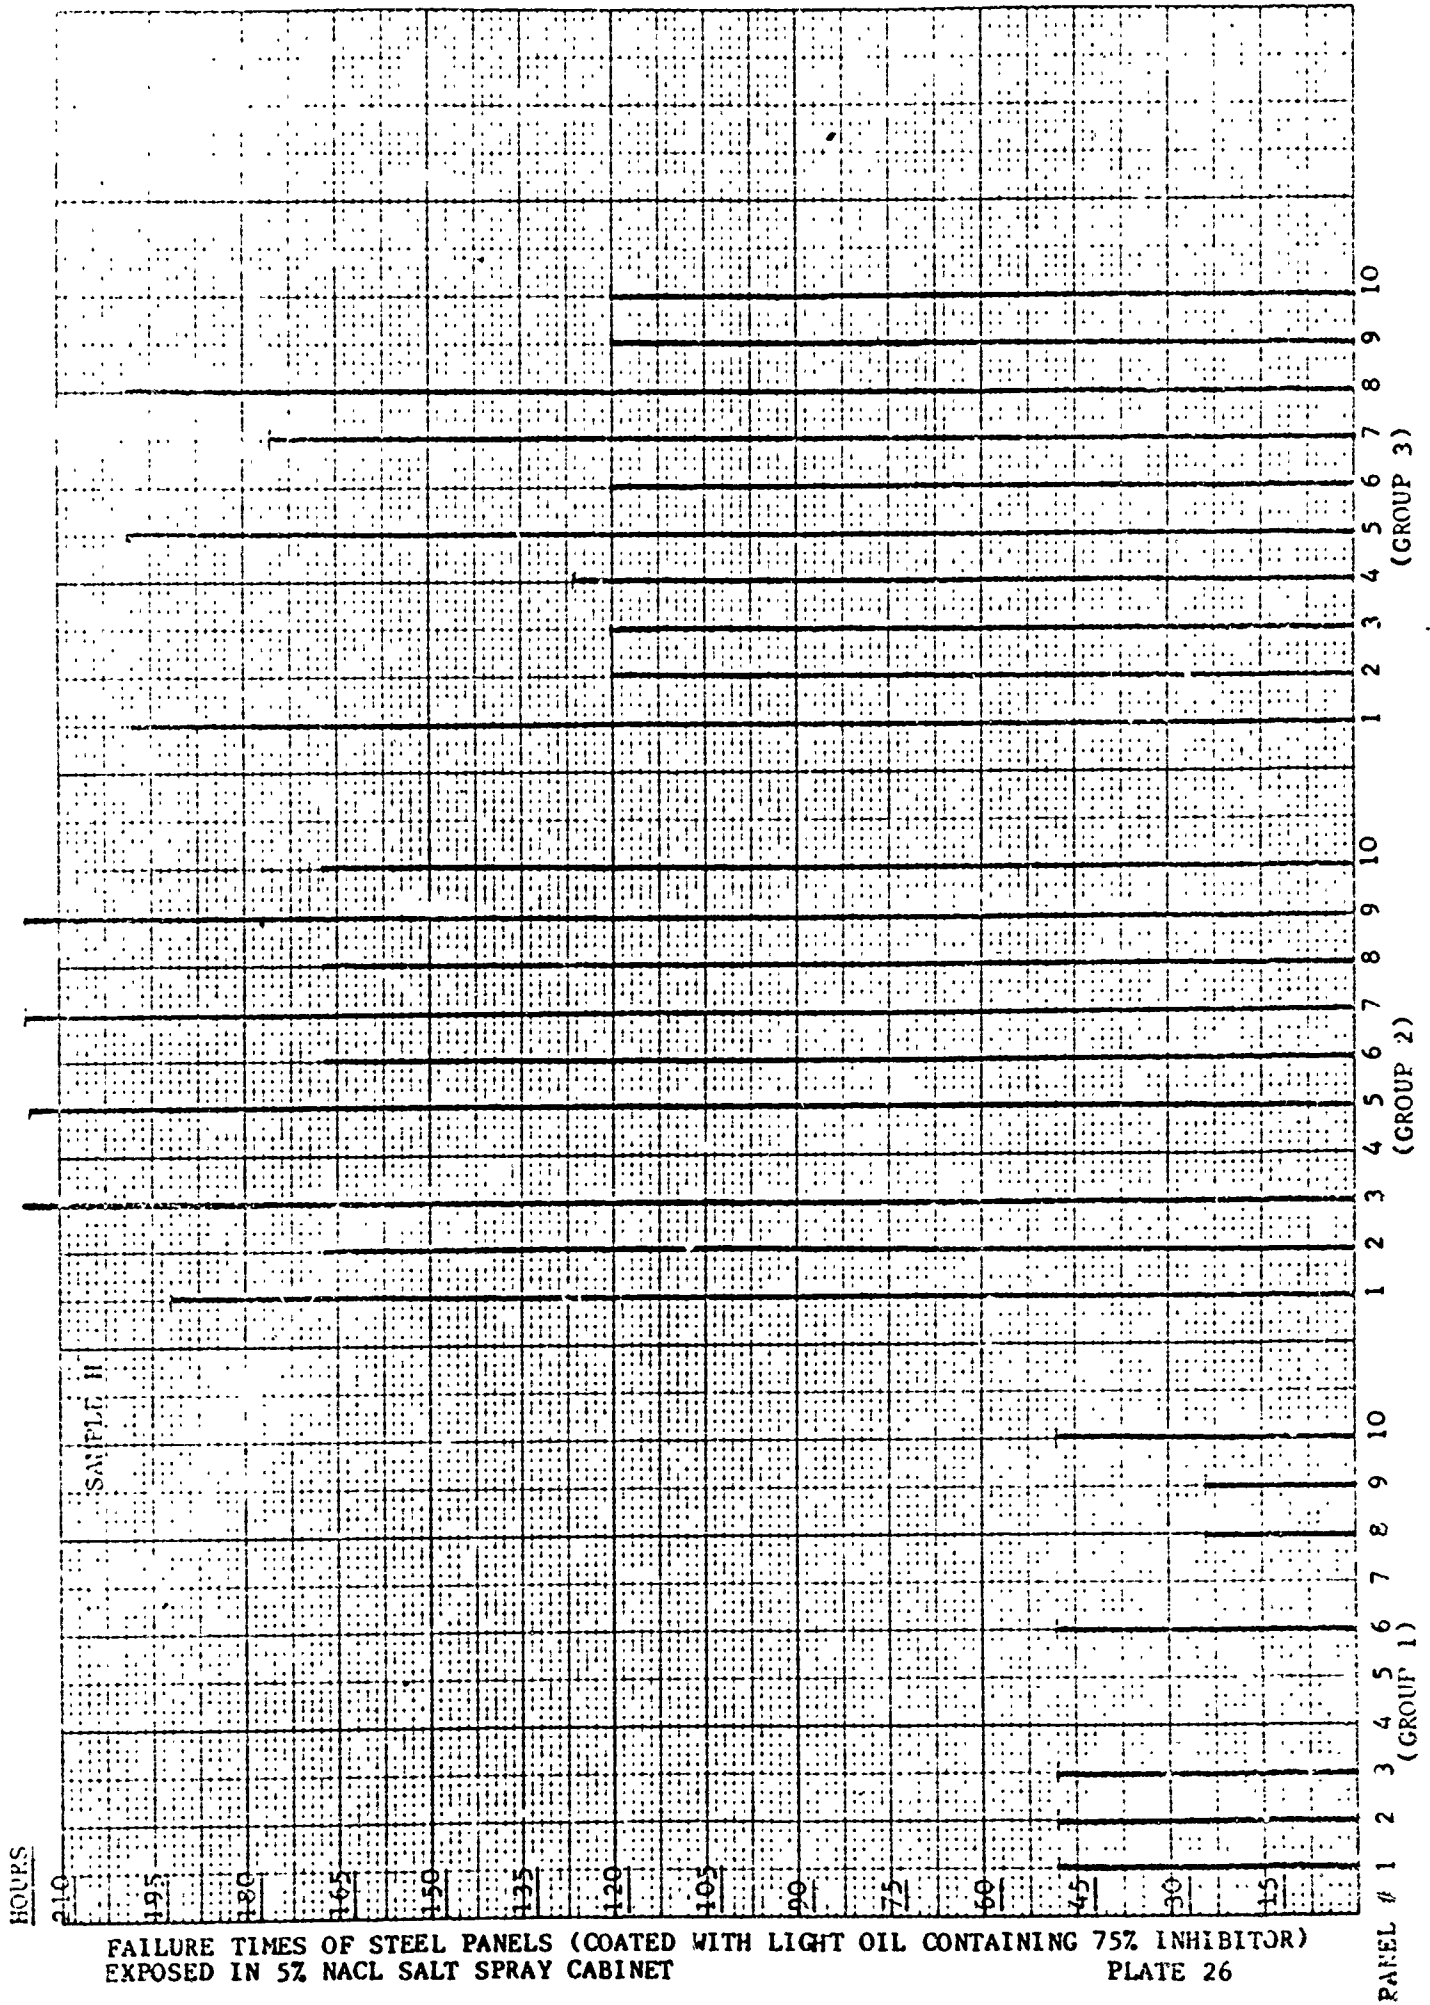
PLATE 26

FAILURE TIMES OF STEEL PANELS (COATED WITH LIGHT OIL CONTAINING 75% INHIBITOR)
EXPOSED IN 5% NAEL SALT SPRAY CABINET
